# Seismic Risk Mitigation in Palestine

**" Support Action for Strengthening Palestinian-administrated Areas capabilities for Seismic Risk Mitigation "**

**An-Najah National University  
Urban Planning and Disaster Risk Reduction Center**

# RETROFITINGT

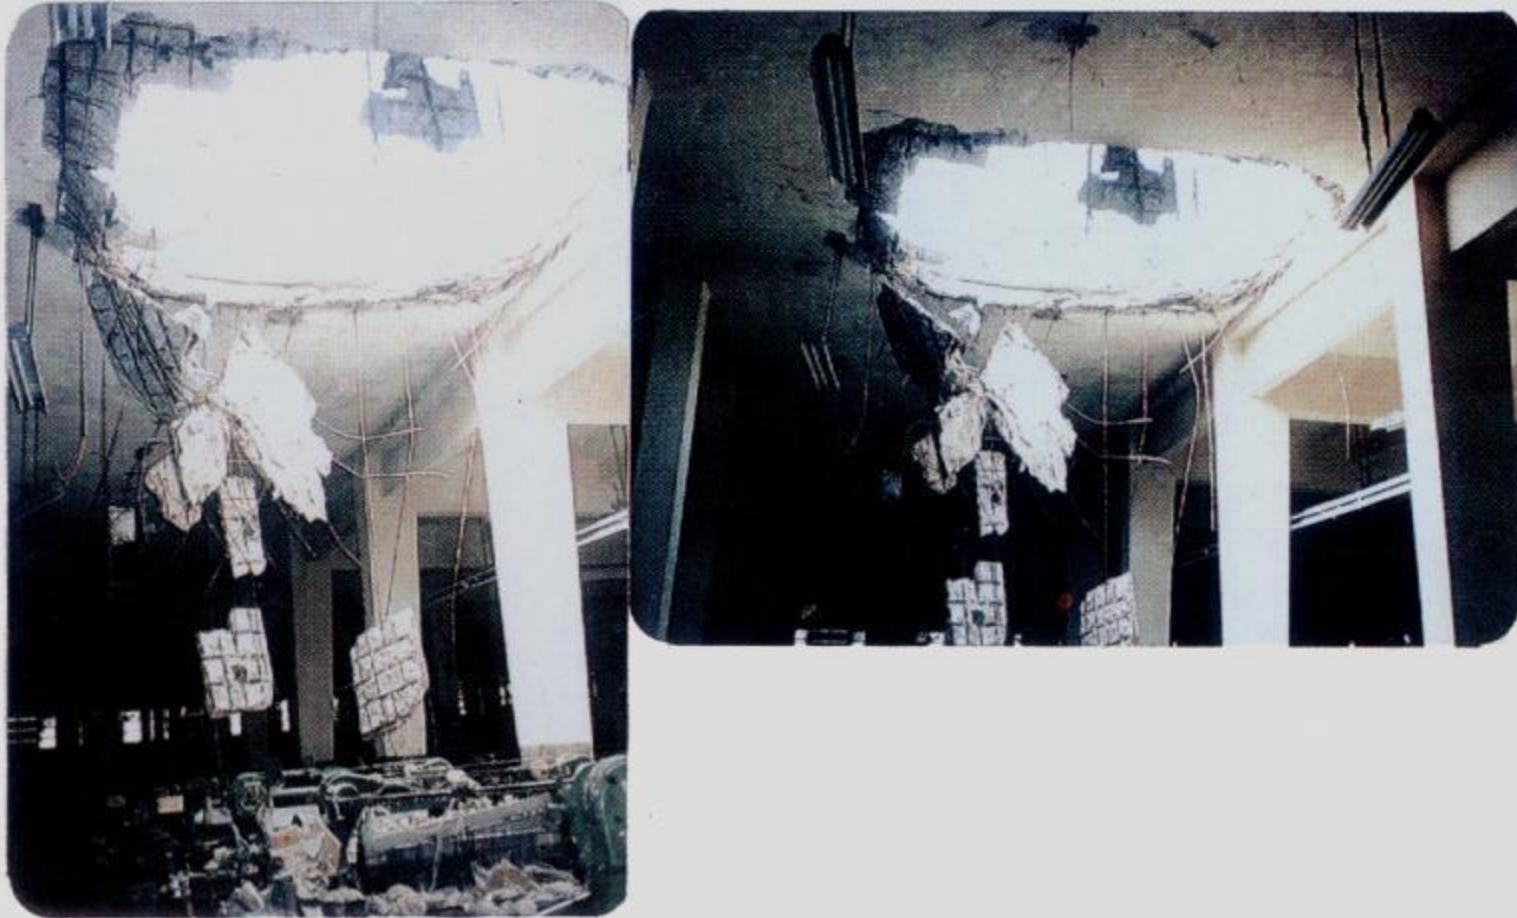
سقوط بلاطة سقف المصنع نتيجة الصدا وتراكم المياه فوقها .

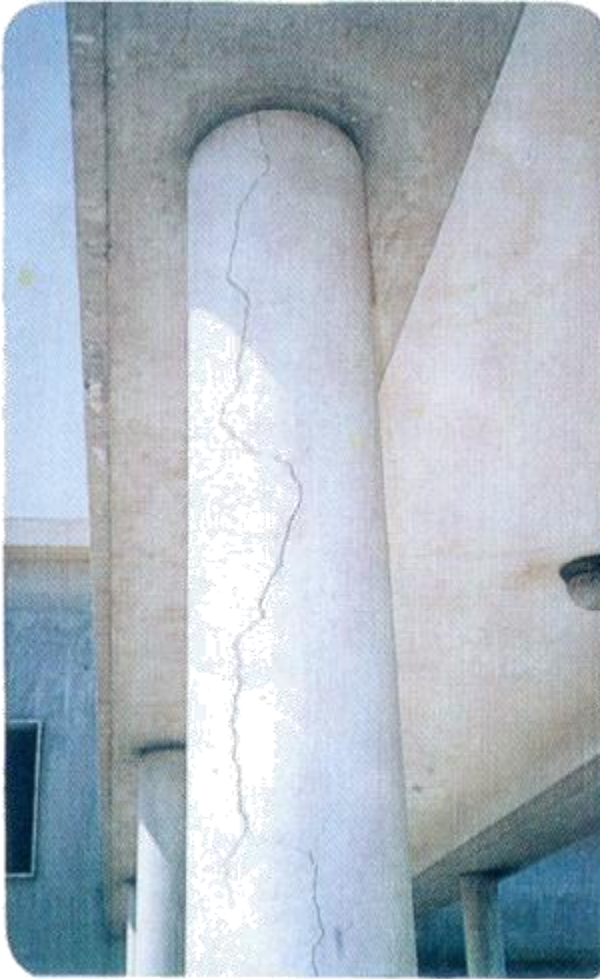
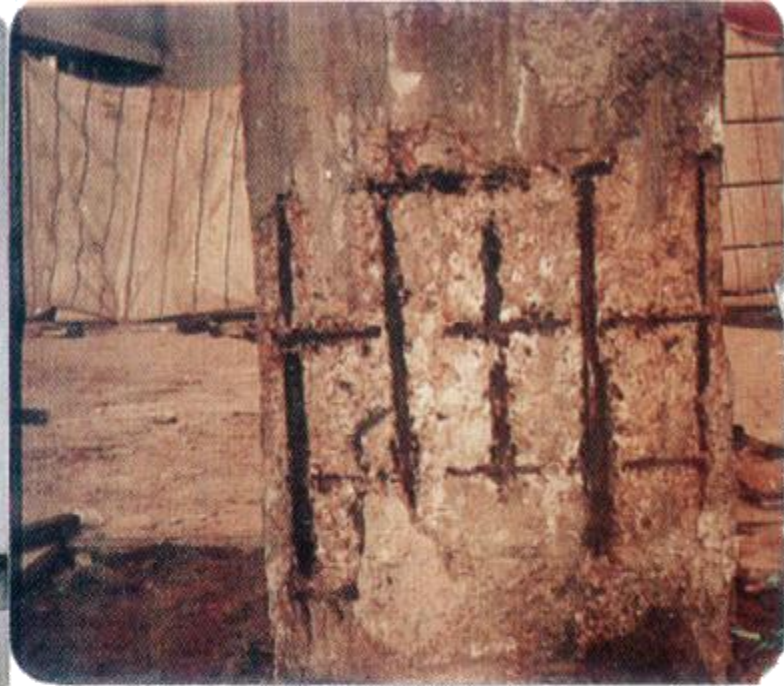
بقع الصدأ ذات اللون البني

(شرح رأسى (موازى لحدید التسلیح) سببه الصدأ

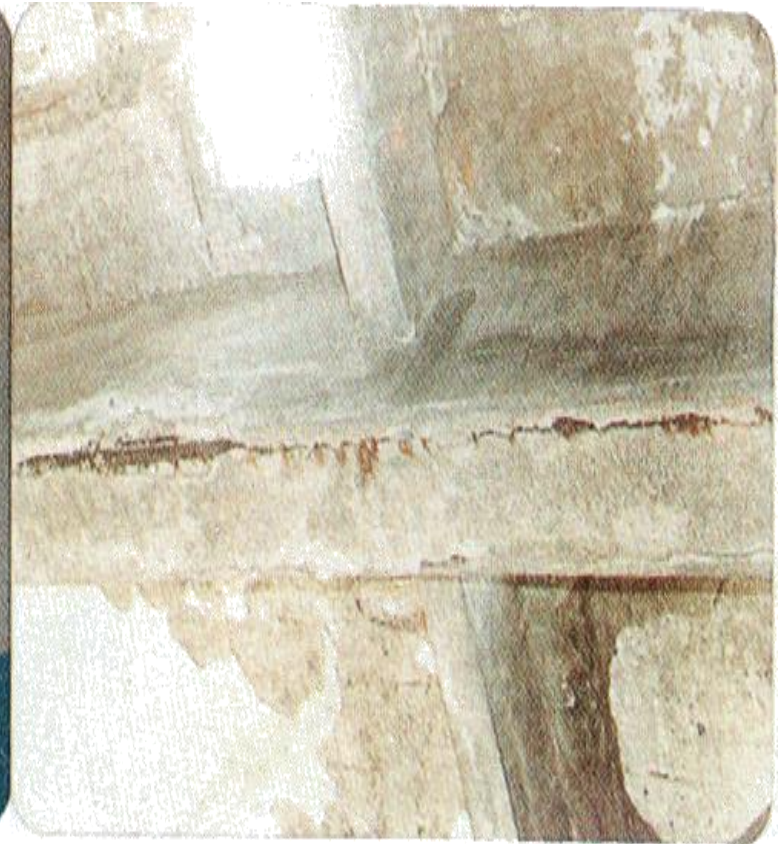
سقوط الغطاء

الخرسانة للبلاطة بسبب الصدأ

شروخ صدأ الحديد

الطولية الموازية للتسليح السفلي للكمره

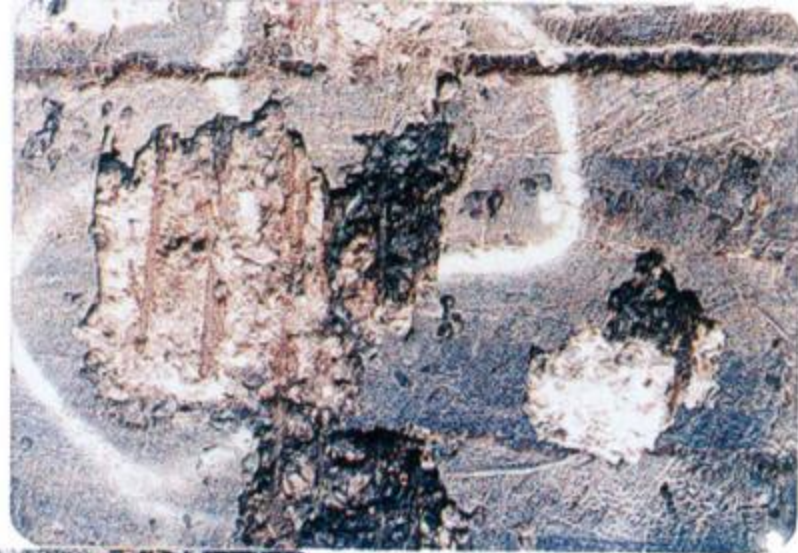
تأثير الأحماض

على الخرسانة السطحية

وصول تأثير

الأحماض إلى صلب التسليح

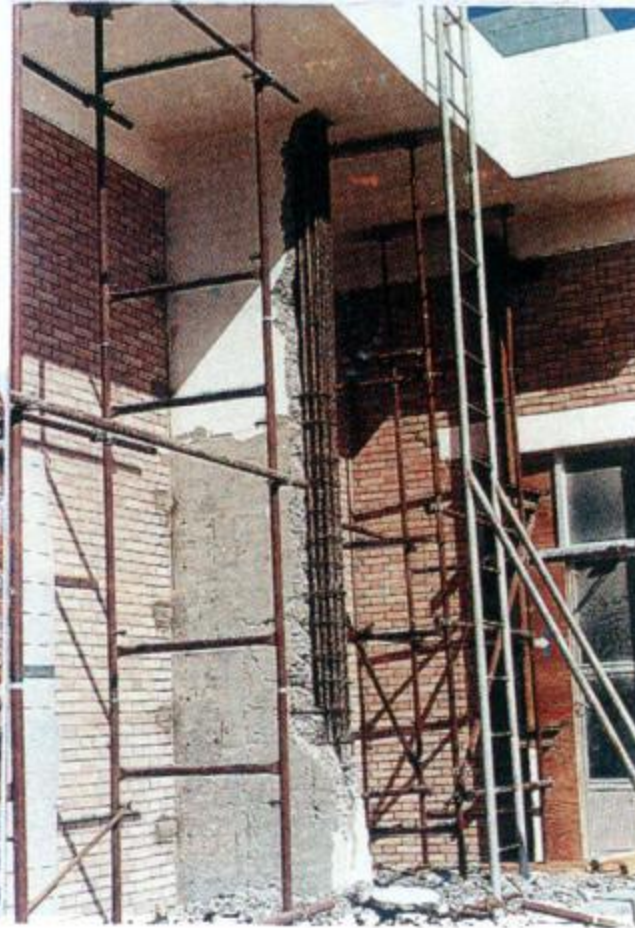
إزالة الخرسانة بحيث تظهر أسياخ

التسليح لإزالة الصدأ من عليها

إزالة الخرسانة بعمق

كاف خلف أسياخ العامور

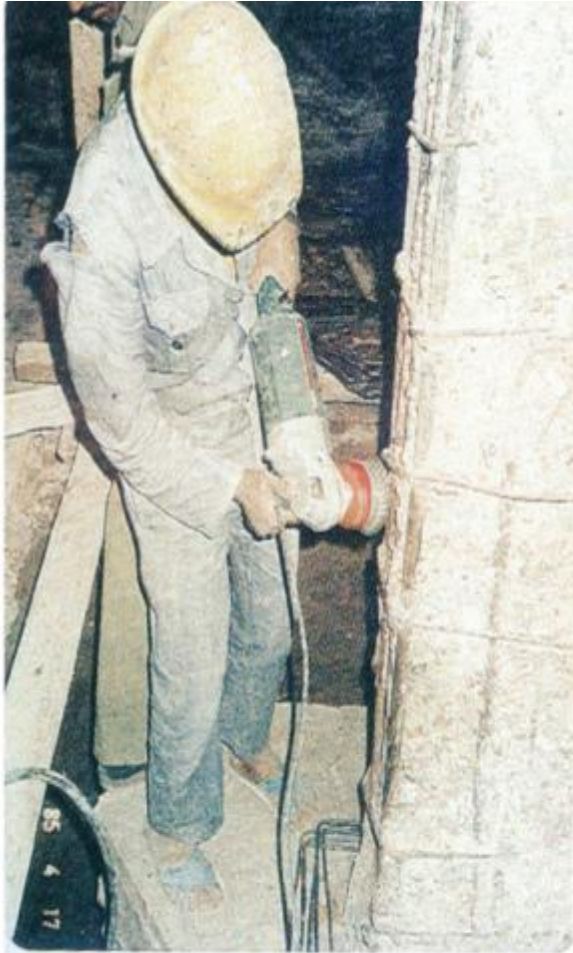
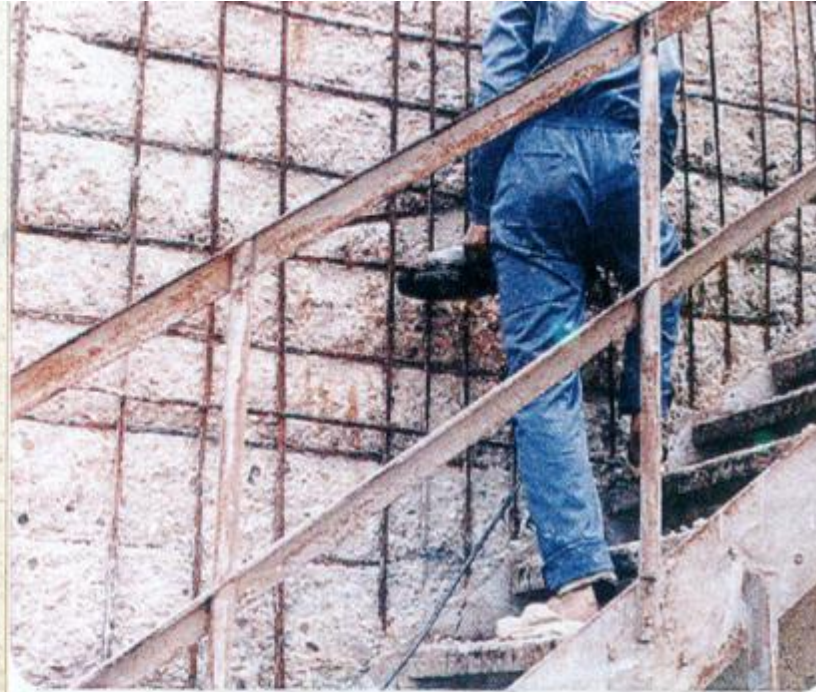
تنظيف صلب التسليح باستخدام الأجهزة الكهربائية
